**Road and Landslide Sediment Source Investigation
And Sediment Reduction Plan
For the Scotts Creek Watershed
Santa Cruz County, California**

**The Scotts Creek Watershed Council
Davenport, California**

March, 2000

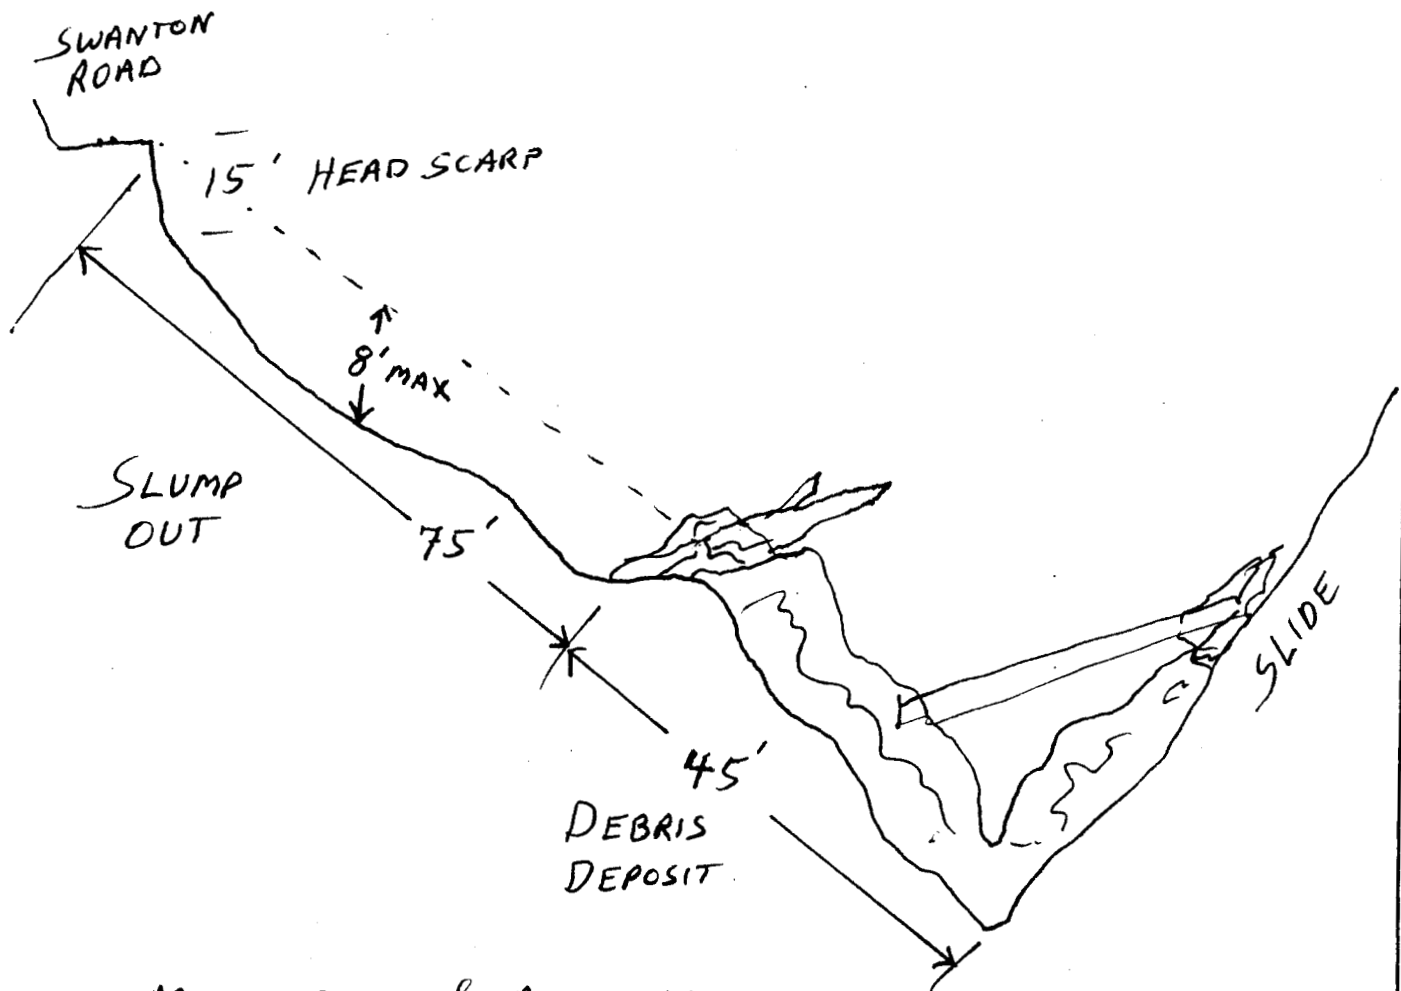
SWANTON ROAD LANE LOSS #3

MANY TREES & ROOT WADS
HUNG UP IN BOTTOM OF ARROYO.

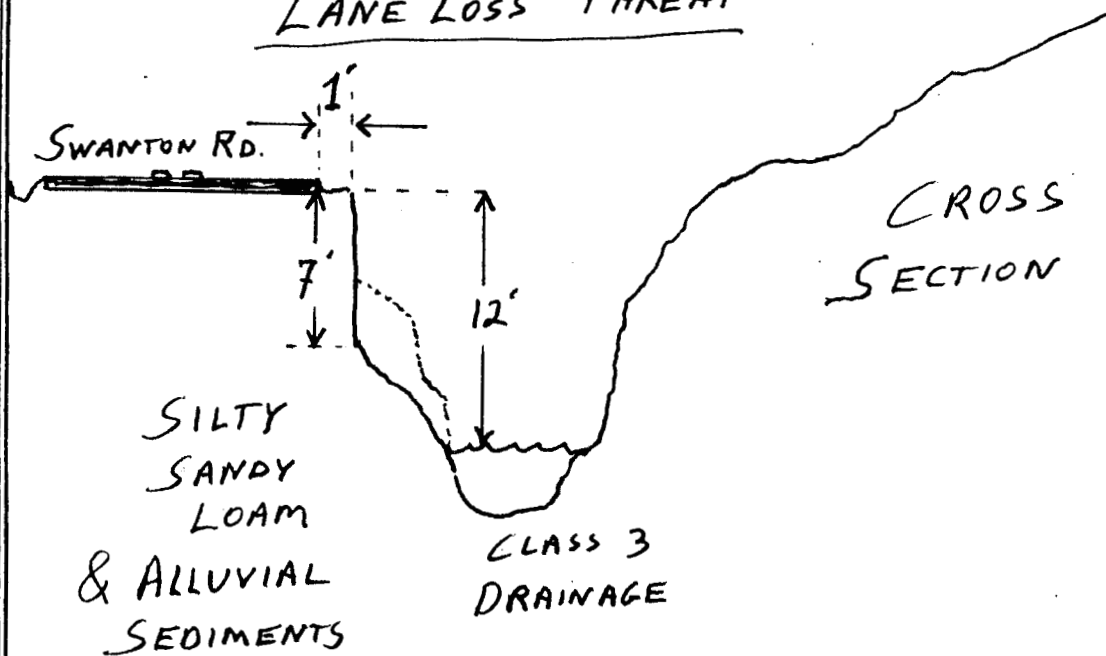
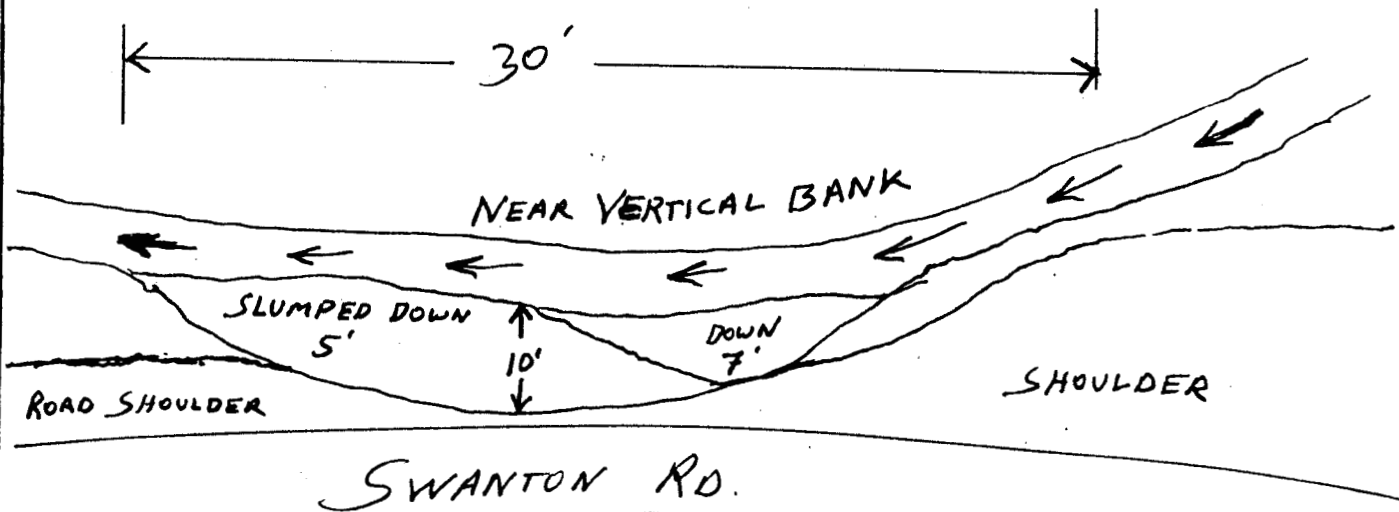
SWANTON ROAD 4.5 MILE MARKER

LANE LOSS THREAT
